**3<sup>rd</sup> International Conference  
Ancient Greek  
and Byzantine Technology**

## «PHIDIAS WORKSHOP» IN OLYMPIA NEW DATA AND NEW INTERPRETATIONS

Themistoklis Bilis  
German Archaeological Institute,  
Magnisali -Bilis Studio  
email: themisbilis@yahoo.gr

**Summary.** The subject of this article is the presentation of new data and new interpretations concerning one of the most important monuments of Olympia, the so-called "Workshop of Phidias". It is a peculiar typologically, quite enigmatic and perhaps for this reason particularly fascinating monument, which has a rich history with a use that starts in classical era and ends in the Byzantine one. A. Mallwitz in the 1950s, systematically investigated the monument and his research yielded reliable stratigraphic data and impressive archaeological finds related to the construction of the statue of Zeus, such as clay moulds, bone tools of goldsmiths, as well as glass sheets. From the 1950s to the present day, various scholars have occasionally contributed to the issues of the monument (glass finds or with the pottery) and the interpretation of the building is taken for granted. In 2019 new research on the monument was organiz

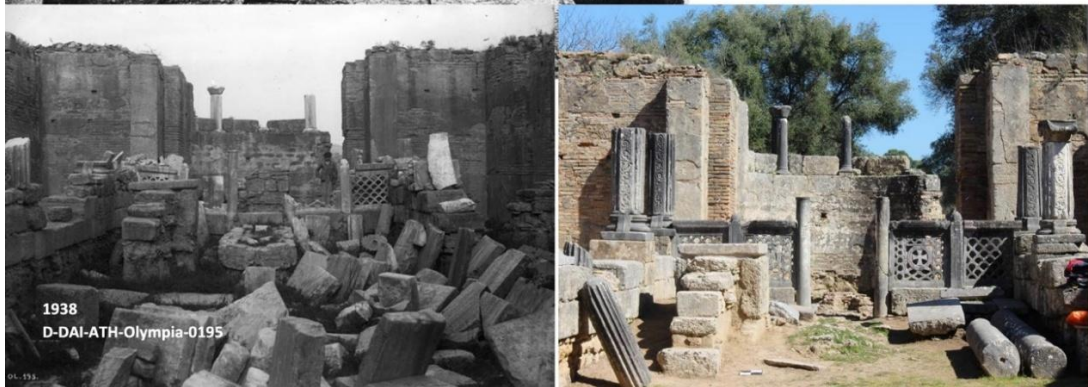
1877 (Staatliche Museen zu Berlin Neg. Nr. AV 922, Bauer et al., 8, Abb. 6)

Figure 1. Olympia. Workshop of Phidias. The Basilika. Interior photos from archives 1877, 1938 and 2019

Since the years when travelers visited Olympia, an important task was the search for the buildings described by Pausanias and especially the famous Workshop of Phidias (fig1,2\*). Most people believed that it was located south of the temple of Zeus. The substantial study of the monument began already in the early years of systematic archaeological research because of the central position of the monument in the site, a short distance and west of the ruins of the temple of Zeus, and probably because some visible parts of the walls stood above the deposits that over the years had covered almost the entire area of Olympia. Indeed, the excavation at the site of the monument took place simultaneously with the excavation of the ruins of the temple of Zeus as early as 1827 and for 6 weeks by A. Blouet and the famous French Scientific Mission of Moria. However, the ruin that was uncovered (with the conventional name Building H) was not identified as the workshop of Phidias. Only in 1846 did Leake place the workshop in the specific location west of the temple. The interest in "Building H" remained undiminished and, when the German excavations in Olympia began (1877), the old French excavation continued.<sup>3</sup> The revelation of the classical foundation of the

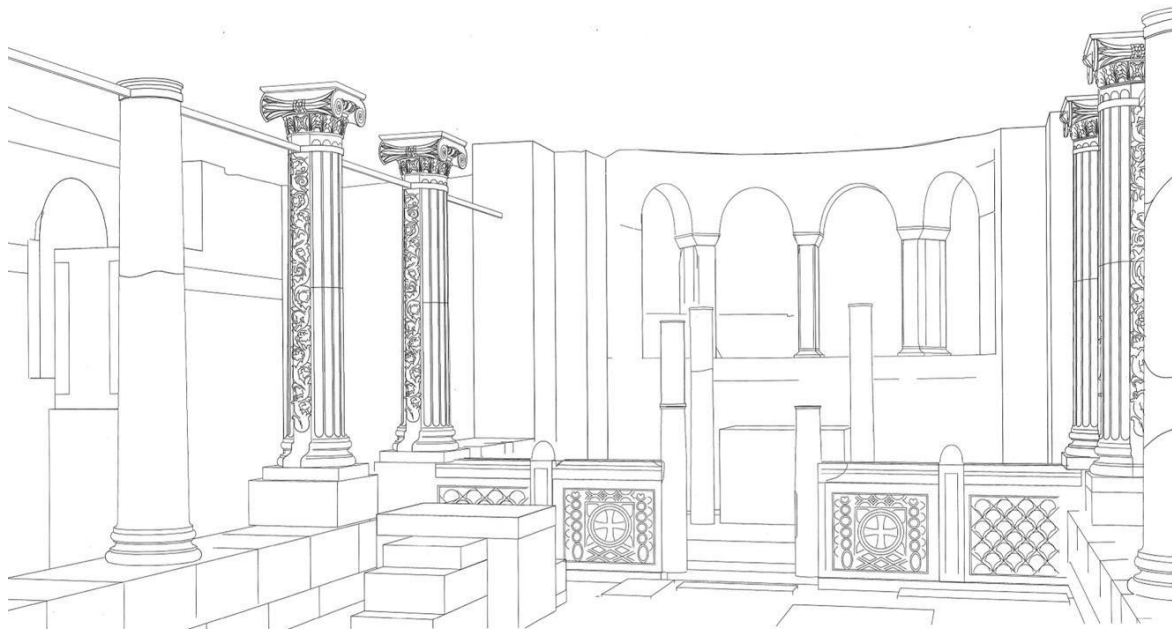
Figure 30. Olympia. Workshop of Phidias. Restoration proposal. Detail (Th. Bilis).

measurements were carried out using modern and traditional methods by the writer, A. Sotiropoulos, conservator DAI, D. Giannoulis and A. Kampouris, architects. Finally, in the context of this new architectural study and research, new observations were made, related to the many, still open, issues of representation of the building phases and key details of the monument (fig.7, 29-30).
